Boat Reviews by Jack Hornor N.A.

Valiant 40

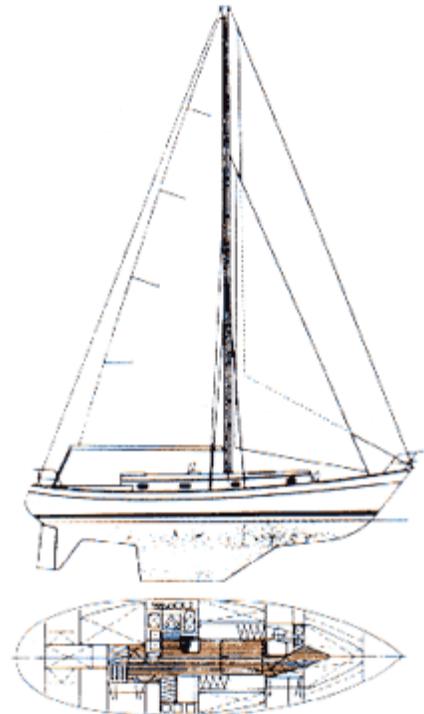
Perry was convinced that cruising boats did not have to be slow and sluggish in order to be safe and comfortable offshore. He also recognized the aesthetic appeal of traditionally styled cruising boats, and he set out to design a boat that was the best of both worlds. In plan view (looking down from atop) the Valiant 40 has a very traditional shape with full ends nearly elliptical in appearance. In profile, above the waterline, the appearance is a combination of new and old. The straight stem is modern in appearance, the spring of the sheer slightly more pronounced than traditional double-enders, and the canoe stern is very traditional. The box-like trunk cabin also lends to the boat's traditional appearance.

Below the waterline the story is quite different. The high prismatic coefficient, low wetted

surface area, low displacement to length ratio and long waterline more resemble a race boat of the early 1970s than an offshore cruiser of that era.
